Summary Report on Building Performance: Hurricane Katrina

Summary Report on Building Performance: Hurricane Katrina 2005

This is a summary of the information that can be found in the full MAT report Hurricane Katrina in the Gulf Coast: Building Performance Observations, Recommendations, and Technical Guidance (FEMA 549, 2006).

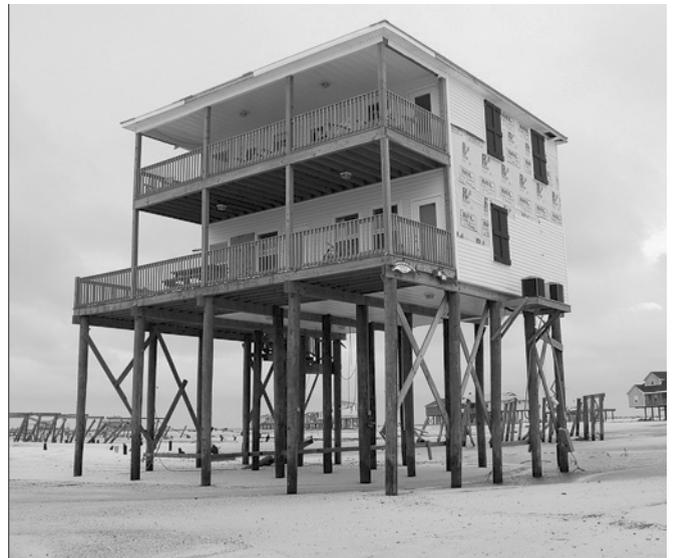
Figure 2-1. Successful example of well-elevated and embedded pile foundation following Katrina. Note adjacent building failures where foundations were not high enough or where pile embedment was insufficient (Dauphin Island, Alabama).

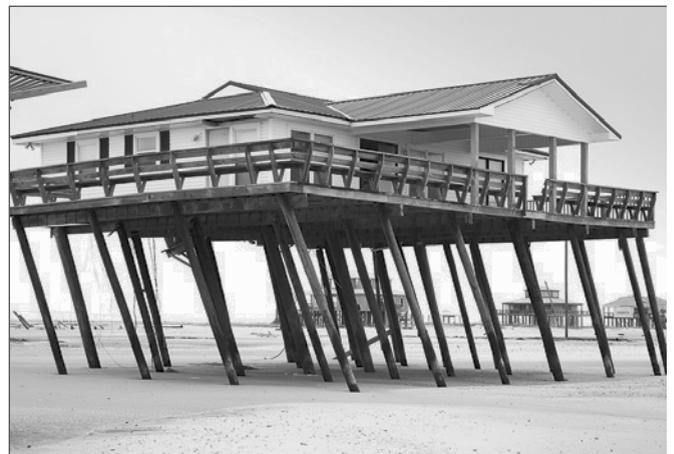
Figure 2-2. House that nearly failed due to insufficient pile embedment (Dauphin Island, Alabama)

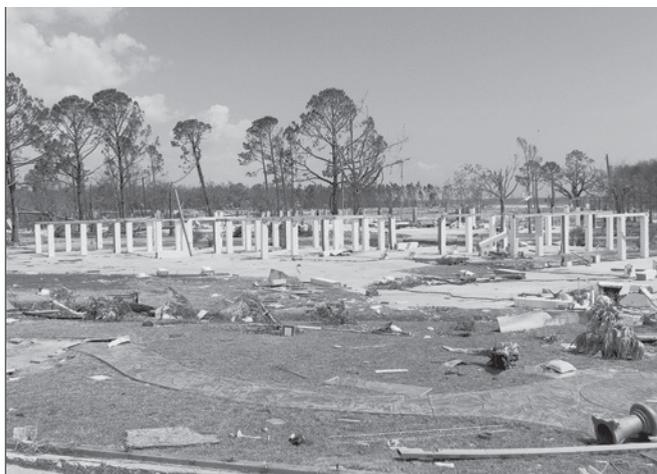
Figure 2-3. Typical building failures when surge and waves exceeded pier foundation height (Long Beach, Mississippi)

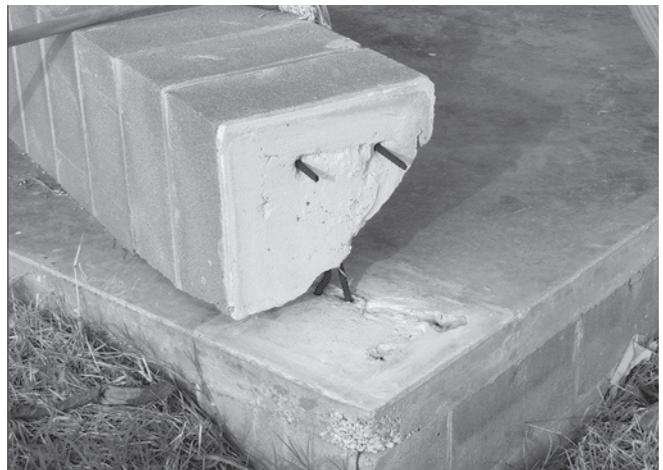
bars) or inadequate splicing, shallow footings, or poor connections between the pier and the footing. Failures usually took the form of pier breakage or pier separation from the footing (see Figure 2-4).

Figure 2-4. Pier connection failure (Belle Fontaine Point, Jackson County, Mississippi)

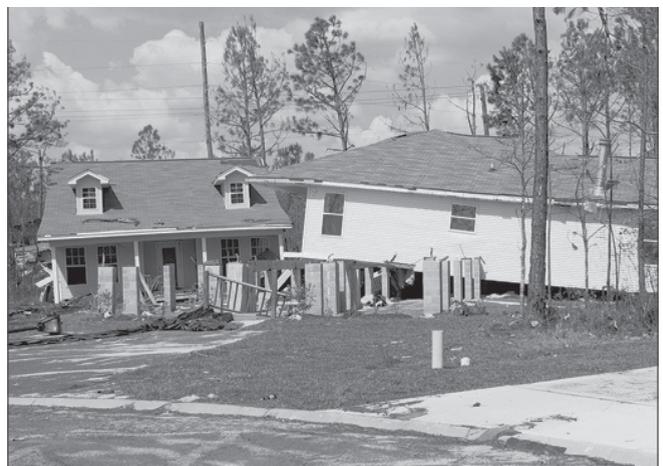
For example, 19 of 32 new houses in a Pass Christian subdivision (approximately 1 mile from the Gulf shoreline) floated off of their pier foundations due to flood heights of approximately 8 feet above the BFE and poor connections between the building and the floor beams or the floor beams and the piers (see Figure 2-5). Buildings that remained attached were flooded to approximately 8 feet above the floor elevations,

Figure 2-5. Buildings floated off of pier foundations (Pass Christian, Mississippi)

but received minimal structural damage and appeared repairable.

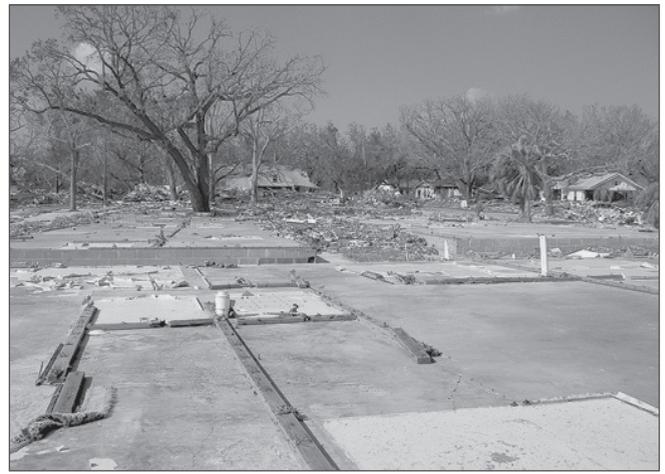
Figure 2-6. Waves, surge, and floating debris destroyed many single family homes on slab foundations. Note the debris from houses that washed landward into other buildings (Biloxi, Mississippi).

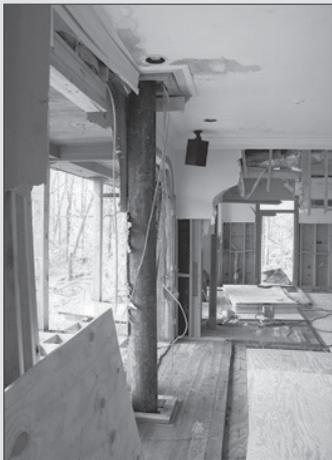
Storm surge and waves reached at least 4 feet (red line) above the elevated floor (Waveland, Mississippi).

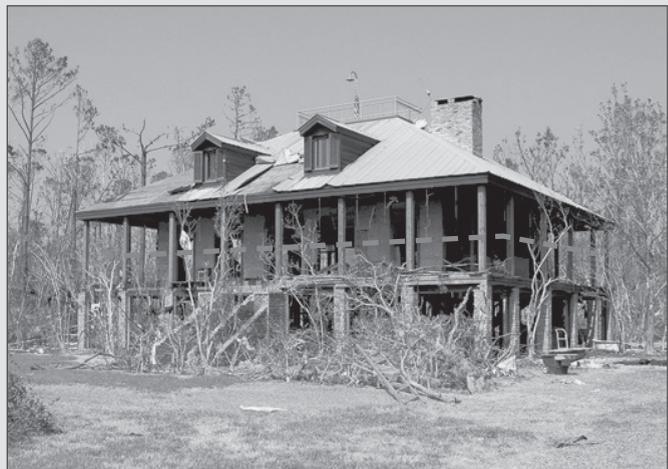
Wave damage to floors and walls, but pole construction left a repairable, surviving building.

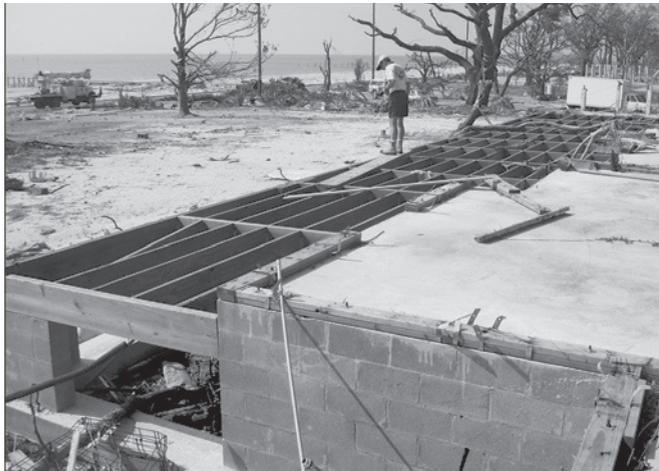
secured to, poured concrete foundations generally remained intact (although with flood damage from inundation). Homes placed on dry-stacked or unmortared piers and secured with helical ground anchors were often pushed off of their foundations by floodwaters and destroyed.

Figure 2-7. Stem wall foundation survived intact, but waves and surge above the floor destroyed the house, sweeping it off the foundation (Waveland, Mississippi).

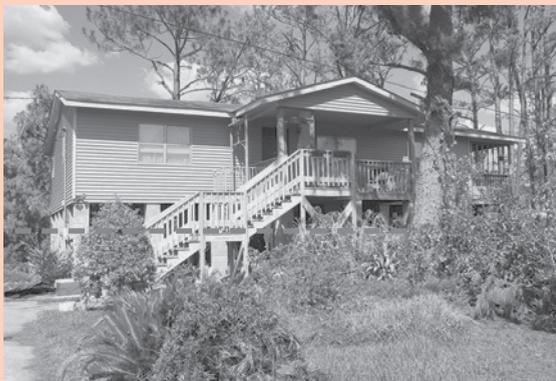
This house in Lacombe, Louisiana, was elevated above the flood depths associated with Katrina using FEMA mitigation grant funding. Note the estimated water line associated with Hurricane Katrina.

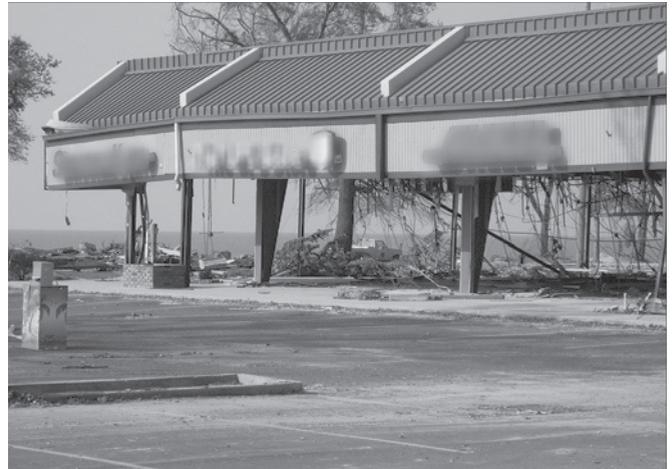
and larger retailers. No type of commercial building constructed on slab foundations near the coastline escaped damage when the storm surge or wave elevations exceeded the first floor levels (see Figure 2-8).

Figure 2-8. Steel frame strip mall construction with exterior wave damage (Gulfport, Mississippi)

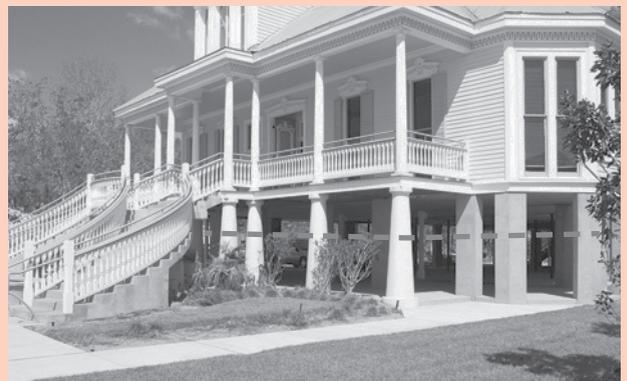
This building in Mandeville, Louisiana, was relocated from New Orleans for use as a restaurant. The local building inspector recommended the elevation seen here, which protected this building from flood damage. Note the estimated flood depth in relation to the first floor.

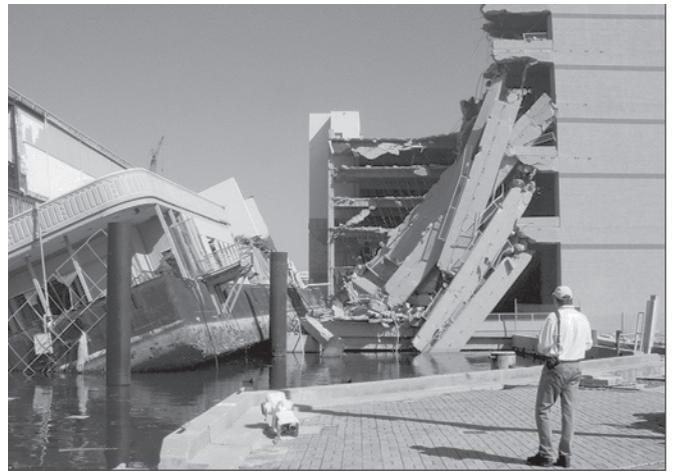
Some of the high-rise casino hotels and condominiums close to the shoreline experienced some of the worst storm surge depths and wave heights. The foundation stability of the large buildings was not affected; most were cast-in-place, reinforced concrete. Although sited near the shoreline and experiencing the worst flood conditions, the high-rises were some of the better examples of successes. However, some of the high-rise casino hotels were damaged when adjacent casino barges were pushed into them by storm surge (see Figure 2-10).

Figure 2-10. Parking deck collapse due to impact by casino barge, on left (Biloxi, Mississippi)

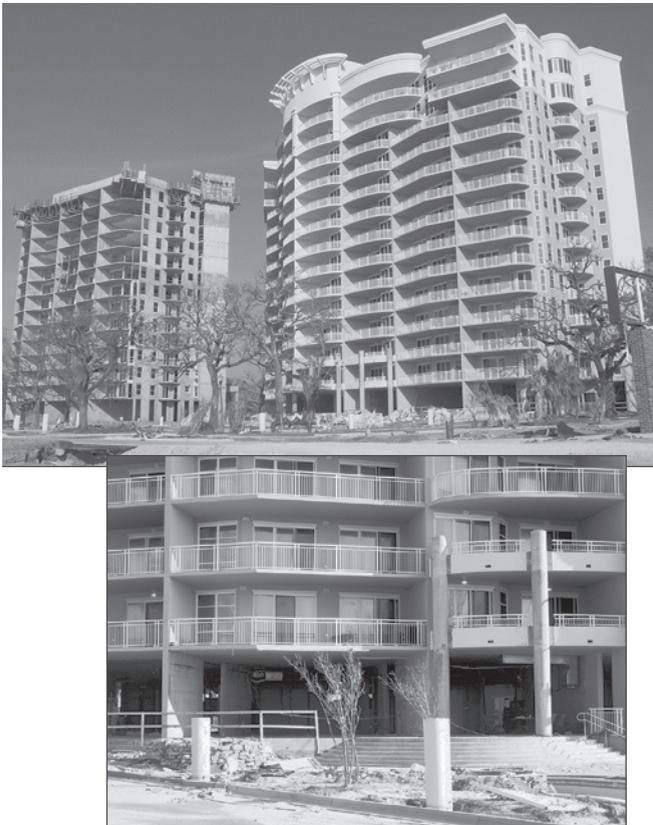
Figure 2-9. High-rise buildings along Beach Boulevard received nonstructural flood damage to the lower floor, and no apparent flood or wind damage to higher residential floors (Gulfport, Mississippi)

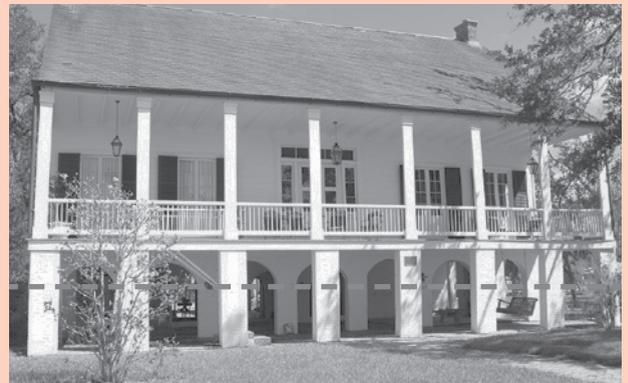
This 100-year-old building on the National Register of Historic Places sustained minimal flood damage due to elevation on taller piers (an architectural choice, not a requirement when the building was constructed in 1905). Note the estimated flood depth in relation to the first floor (Mandeville, Louisiana).

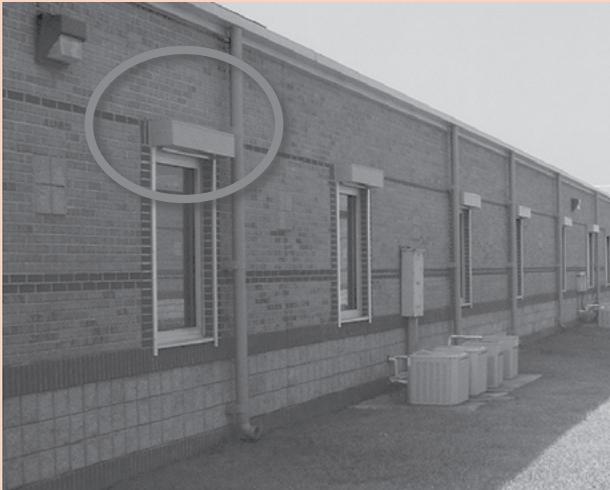
Ocean Springs Middle School in Ocean Springs, Mississippi, was awarded FEMA mitigation grant funding in September 1998 for the installation of roll-down storm shutters on all exterior classroom windows to protect students and faculty in the event hurricane-force winds should affect the area. The school was used as a shelter during Hurricane Katrina for as many as 400 people. Following Hurricane Katrina, the MAT observed only minimal damage to the facility. In addition to the use of the storm shutters, other windows on the building were observed to have polycarbonate glazing.

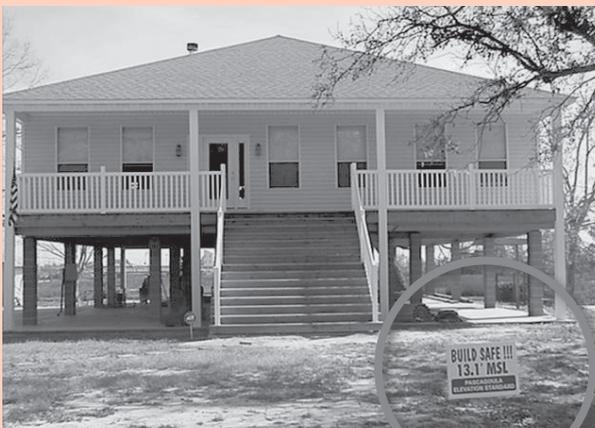
Following Hurricane Georges in 1998, the City of Pascagoula, Mississippi, established an elevation standard higher than the BFEs stated on the community's FIRMs. In some cases, this represented up to a 5-foot increase above mapped BFEs. As a result, buildings impacted by Hurricane Katrina that were built to this standard suffered less flood damage than older housing built to lower elevation requirements. According to the effective FIRM at the time of Hurricane Katrina, the building is located in Zone V with a BFE of 12 feet.

This photo was taken pre-Katrina c.1999/2000. Note the "Build Safe!" sign in front yard (circle), (Pascagoula, Mississippi).

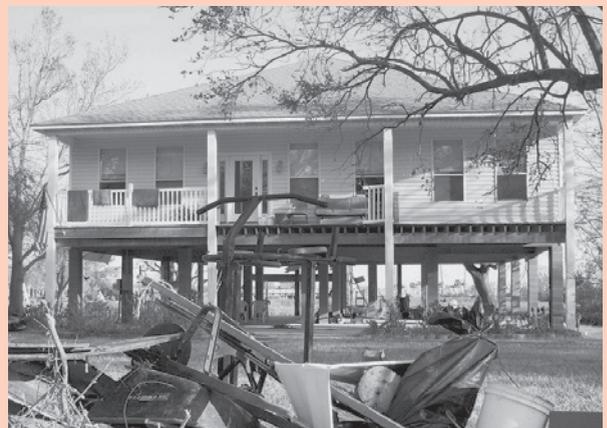
This photo was taken post-Katrina, illustrating the survival of this elevated building.

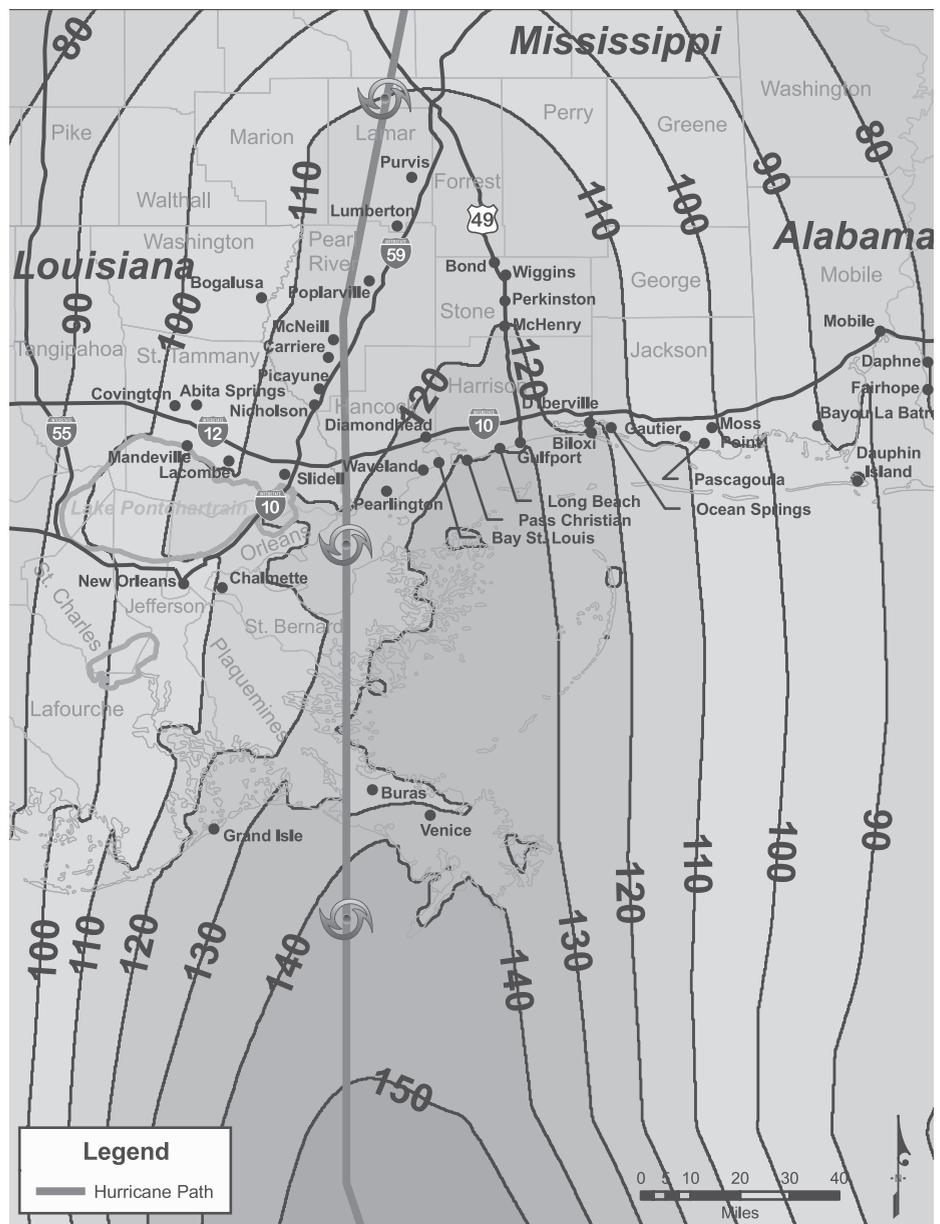
Figure 2-11. Wind swath contour plot of 3-second gust wind speeds in mph at a height of 10 meters above ground (open exposure) based on HAZUS-MH wind field methodology. Source: ARA

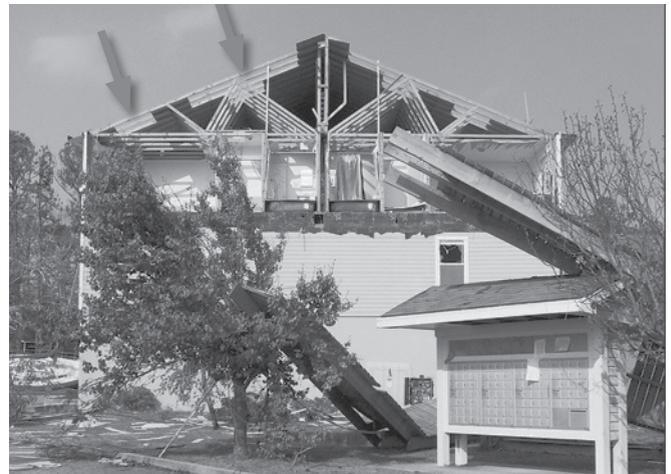
Figure 2-12. Failure of the gable end wall of this apartment building led to pressurization of the attic and the release of sheets of plywood sheathing. Note the plywood roof sheathing “unzipped” by wind pressures (arrows), (Ocean Springs, Mississippi).

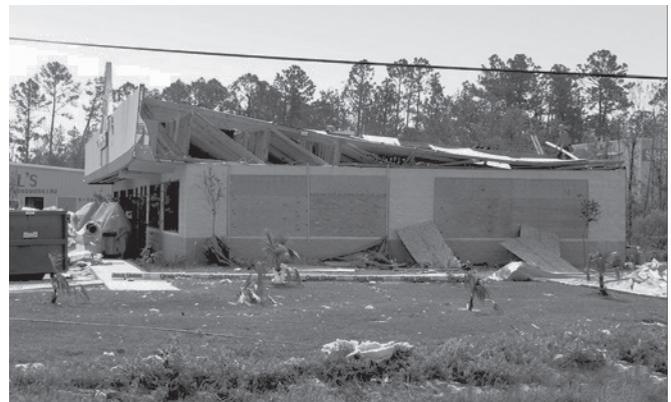
Figure 2-13. Failure in a wood frame commercial building. Trusses lost roof sheathing, allowing trusses to tip over (Ocean Springs, Mississippi).

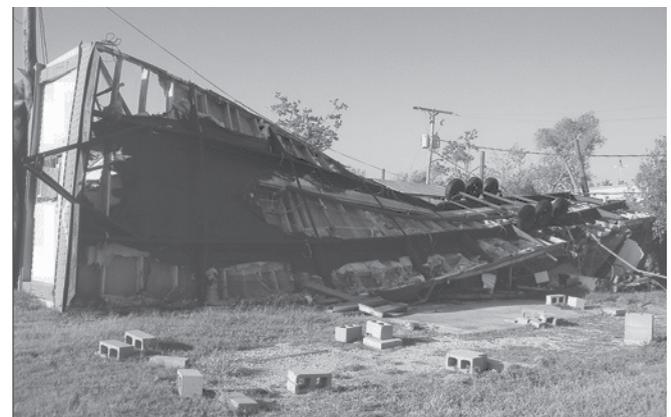
anchored, manufactured home damage under wind loads was less significant. Unanchored or improperly anchored homes or homes with damaged anchors were prone to wind-related damage (see Figure 2-14).

Figure 2-14. Manufactured home rolled over by Hurricane Katrina's winds (Chalmette, Louisiana)

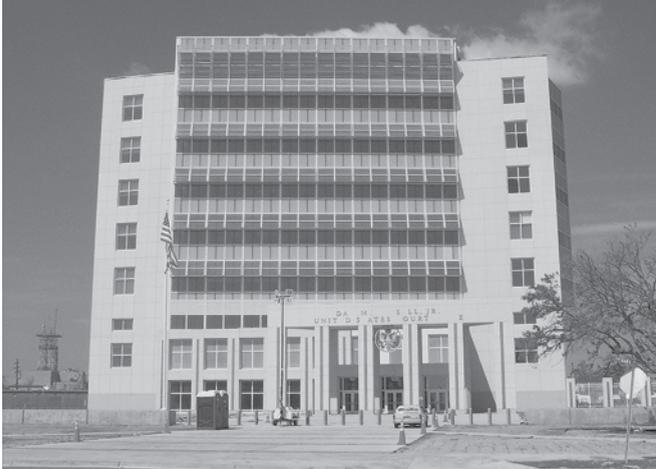
In general, reinforced concrete and heavy steel buildings observed by the MAT performed well structurally (see Figure 2-15). While the MAT noted little structural damage to most buildings constructed with reinforced concrete frames, extensive damage to unreinforced masonry buildings was observed.

Figure 2-15. Reinforced concrete/steel frame building that performed well structurally, but did have some building envelope damage and roof mounted HVAC equipment damage (Gulfport, Mississippi)

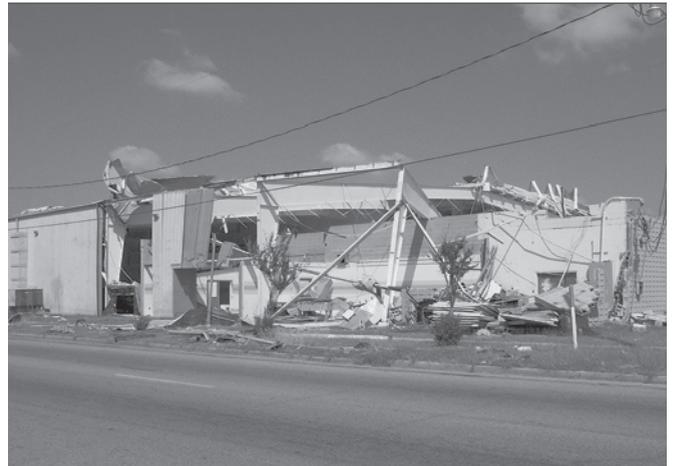
Figure 2-16. Pre-engineered metal building failure (Gulfport, Mississippi)

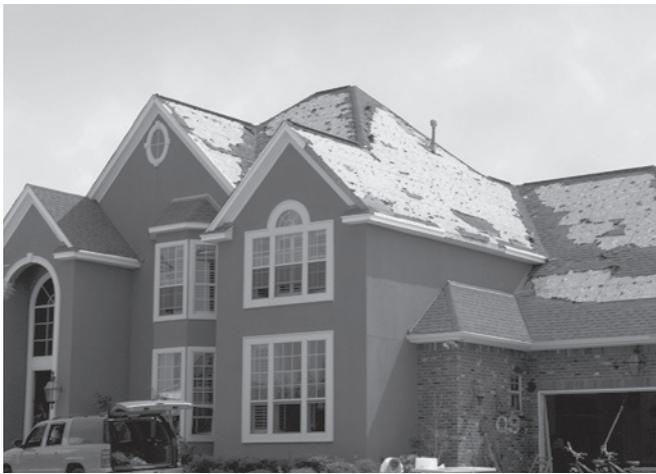
Damage to roof coverings can cause major building performance problems during hurricanes. Rainwater entering a building through damaged roofs causes significant damage to the building contents and interior. Throughout the areas observed by the MAT, many of the residential buildings had asphalt shingle roof coverings. The vast majority of the observed roofs experienced damage, ranging from loss of a few hip trim shingles or tabs to loss of a large number of shingles and underlayment (see Figure 2- 17). Failures of hip/ridge trim shingles and failures along the eaves and rakes were common.

Figure 2-17. Extensive loss of roof covering and underlayment (Slidell, Mississippi)

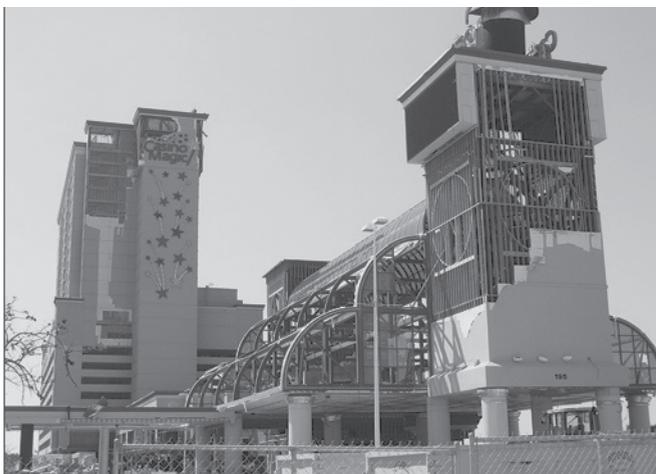
Though there were some observed failures of brick veneers, the most common wall covering damage was to exterior insulation and finish systems (EIFS) and vinyl siding. A large number of EIFS failures were observed on low-rise and high-rise buildings (see Figure 2-18). In addition to puncture by windborne debris, common planes of failure of EIFS assemblies included separation of the synthetic stucco from the insulation, detachment of the insulation from the gypsum board, detachment of the gypsum board from the studs, and failure of the studs.

Figure 2-18. Multi-story building showing severe EIFS damage. In some areas, the gypsum board on the interior side of the studs was also blown away (Biloxi, Mississippi).

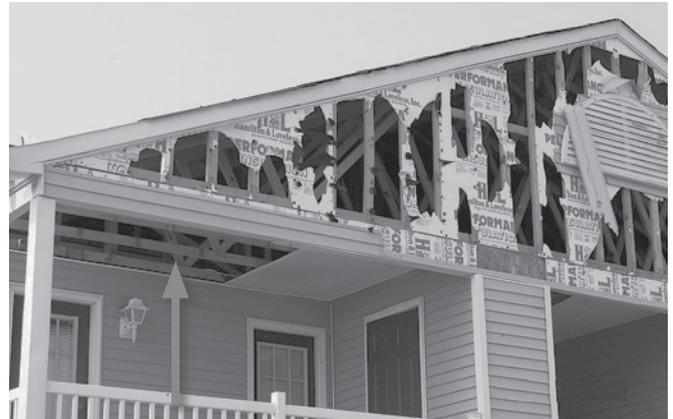
Performance of vinyl siding and soffits was extremely poor. There were numerous significant failures on both new and old buildings throughout the areas observed by the MAT. When vinyl siding was blown off, the underlayment (either asphalt-saturated felt or housewrap) was also often blown away. With loss of the siding and underlayment, wind-driven rainwater was then able to enter the wall cavity, causing water damage and initiating mold growth. High pressures under overhangs and building soffits often lead to progressive structural failures (see Figure 2-19).

Figure 2-19. Loss of vinyl siding and foam insulation at a gable end wall. Note the missing vinyl soffit (red arrow). Not visible was the loss of roof sheathing caused by progressive failure that was initiated by soffit loss (Long Beach, Mississippi).

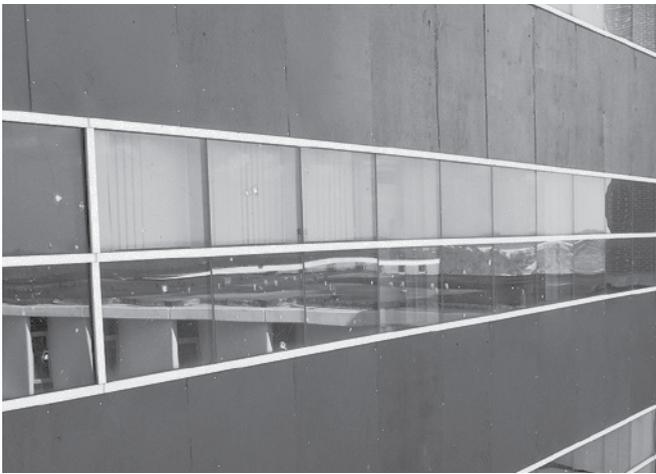
Figure 2-20. The black panels are painted plywood installed after spandrel panels at the Memorial Hospital were damaged by windborne roof aggregate (Gulfport, Mississippi).

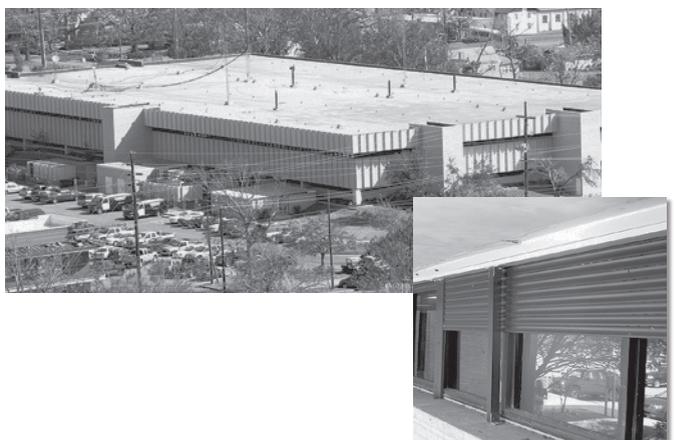
Figure 3-1. The EOC is located near the center of the first floor of the First Judicial District Courthouse in Gulfport. The windows and glazed doors were retrofitted with roll-down shutters, but communications tower damage and vehicle damage from roof aggregate still occurred (Gulfport, Mississippi).

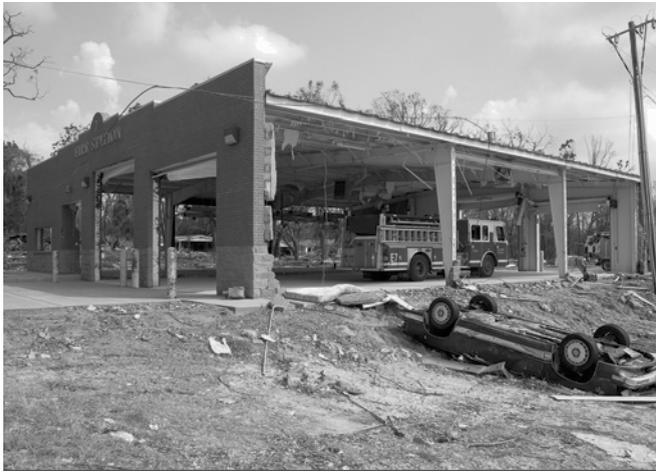
Figure 3-2. Newly constructed Gulfport Fire Station 7 destroyed by waves and storm surge (Gulfport, Mississippi)

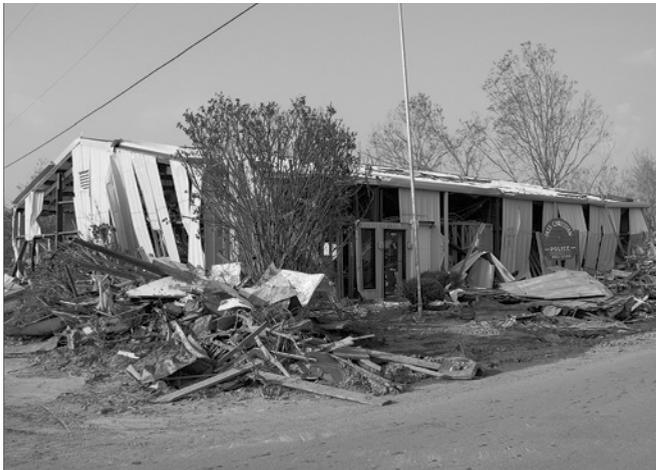
Figure 3-3. Police department destroyed by storm surge (Pass Christian, Mississippi)

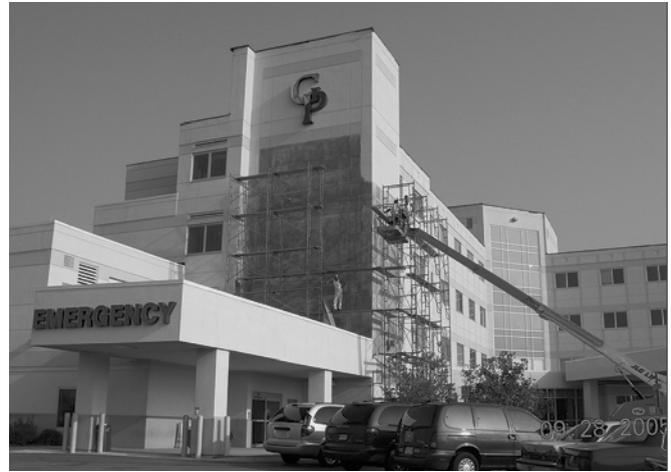
Figure 3-5. General view of Garden Park Medical Center. EIFS repairs were underway at the time the photograph was taken. The entire fourth floor nursing unit was taken off-line for about 1 month due to water leaks caused by roof membrane blow-off (Gulfport, Mississippi).

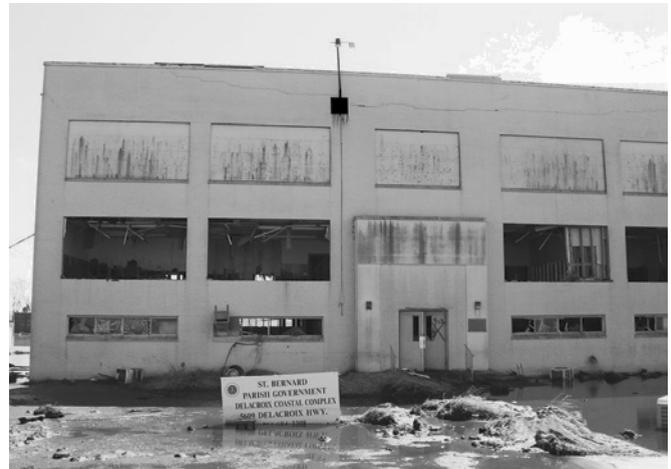
Figure 3-6. Storm surge damage to the St. Bernard Parish Coastal Government Complex (Delacroix, Louisiana)

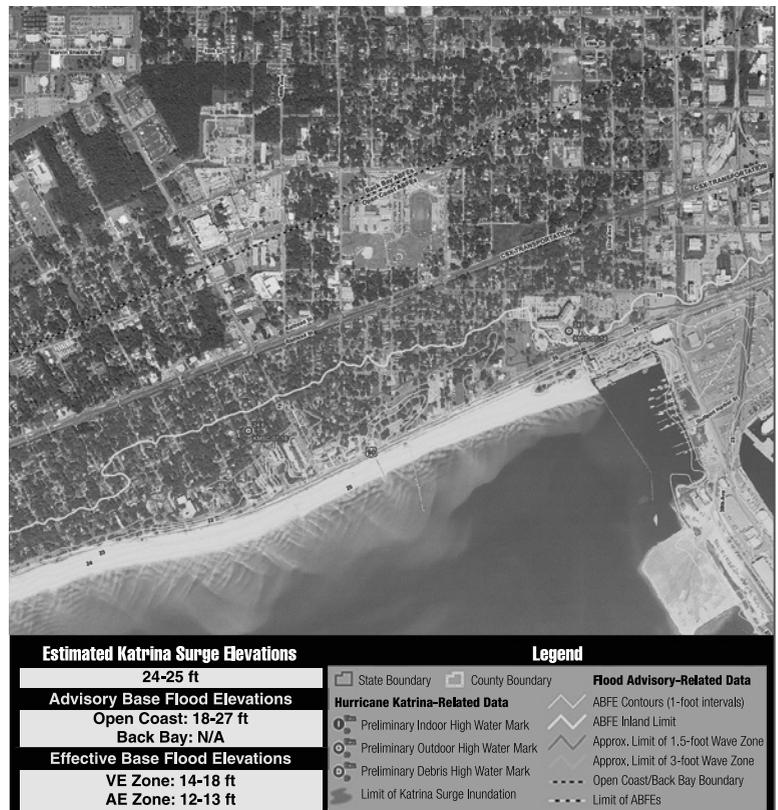
Figure 1. Sample Hurricane Katrina Surge Inundation and Advisory Base Flood Elevations. The shaded region in blue indicates the approximate inland extent of storm surge inundation experienced during Katrina; the ABFE contours are shown in yellow and the predicted inland limit of damaging wave effects during the advisory base flood is shown by the red line. Blue points indicate surveyed Katrina high water mark elevations.

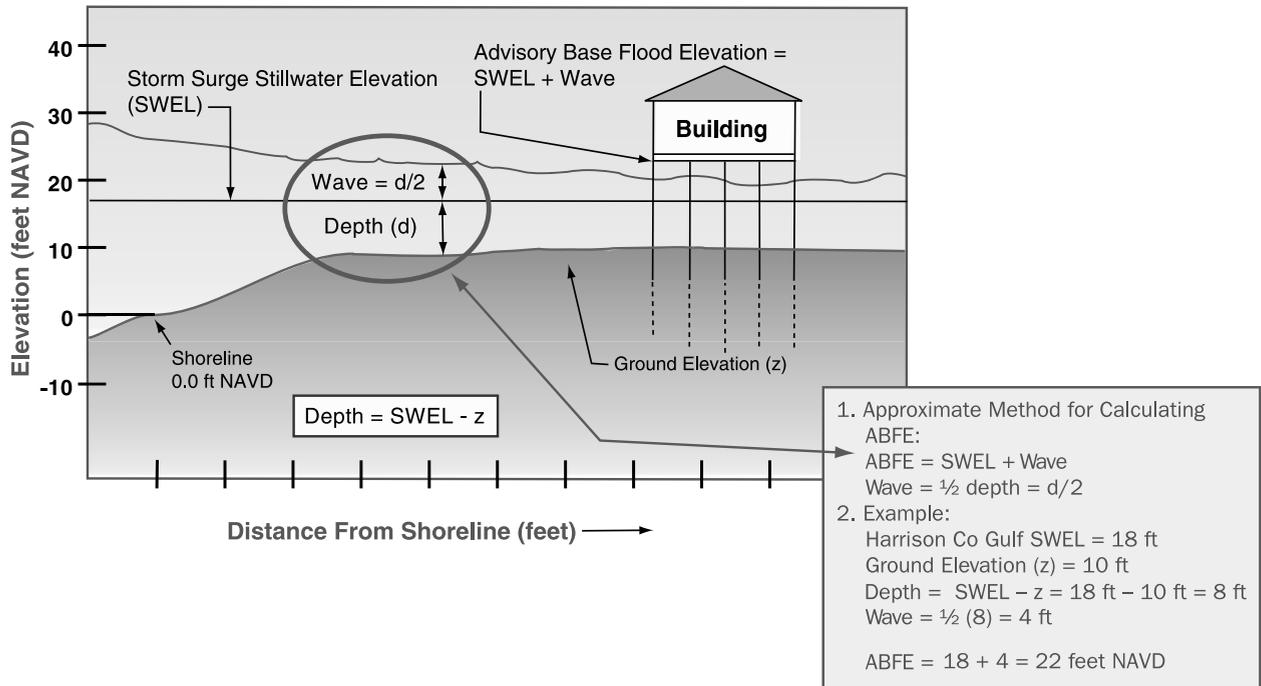
Figure 2. How to determine the Advisory Base Flood Elevation based on the site's ground elevation, applicable advisory elevation, and estimated wave height.

Communities and designers may note that the ABFE procedure is a simplified version of FEMA's Wave Height

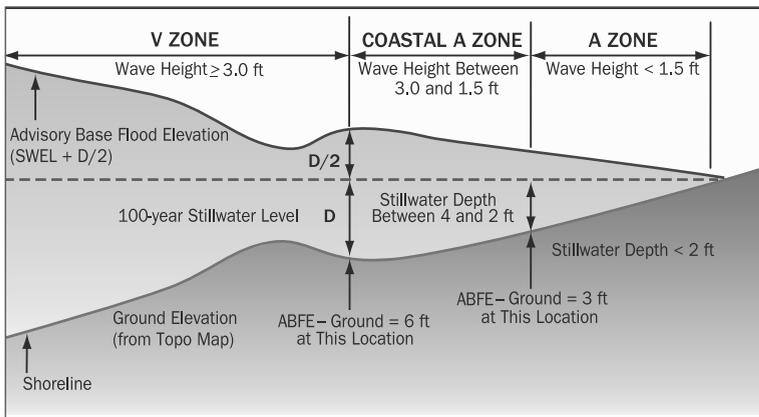
Figure 3. Cross-section showing 1 percent annual chance stillwater elevation, stillwater depth and ABFE, and inland limits of V Zone and Coastal A Zone.
