The Preservation and Repair of Historic Stained and Leaded Glass

33 PRESERVATION BRIEFS

Neal A. Vogel and Rolf Achilles

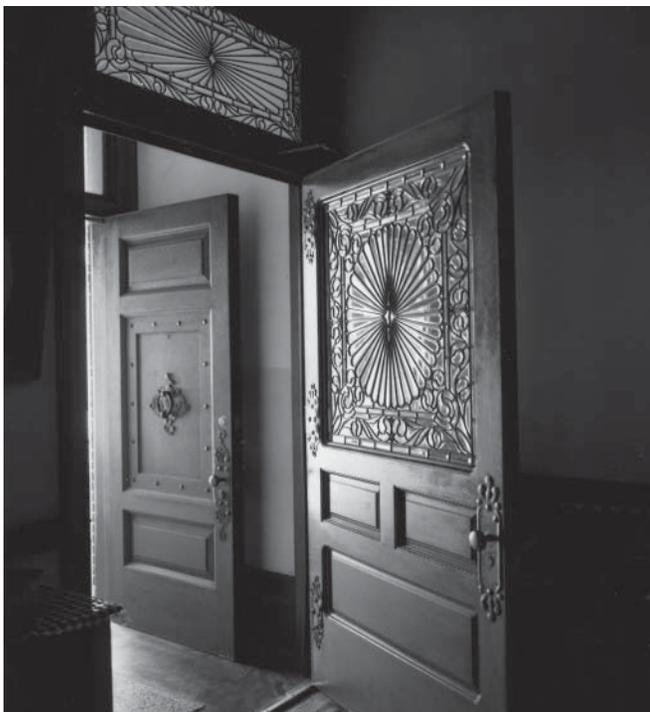
Figure 1. This door and transom suggest the richness of 19th century leaded glass. Photo: Jack E. Boucher, HABS.

Stained and leaded glass can be found throughout America in a dazzling variety of colors, patterns, and textures (Fig. 1). It appears in windows, doors, ceilings, fanlights, sidelights, light fixtures, and other glazed features found in historic buildings (Fig. 2). It appears in all building types and architectural styles—embellishing the light in a great cathedral, or adding a touch of decoration to the smallest rowhouse or bungalow. A number of notable churches, large mansions, civic buildings, and other prominent buildings boast windows or ceilings by LaFarge, Tiffany, Connick, or one of many other, lesser-known, American masters, but stained or leaded glass also appears as a prominent feature in great numbers of modest houses built between the Civil War and the Great Depression.

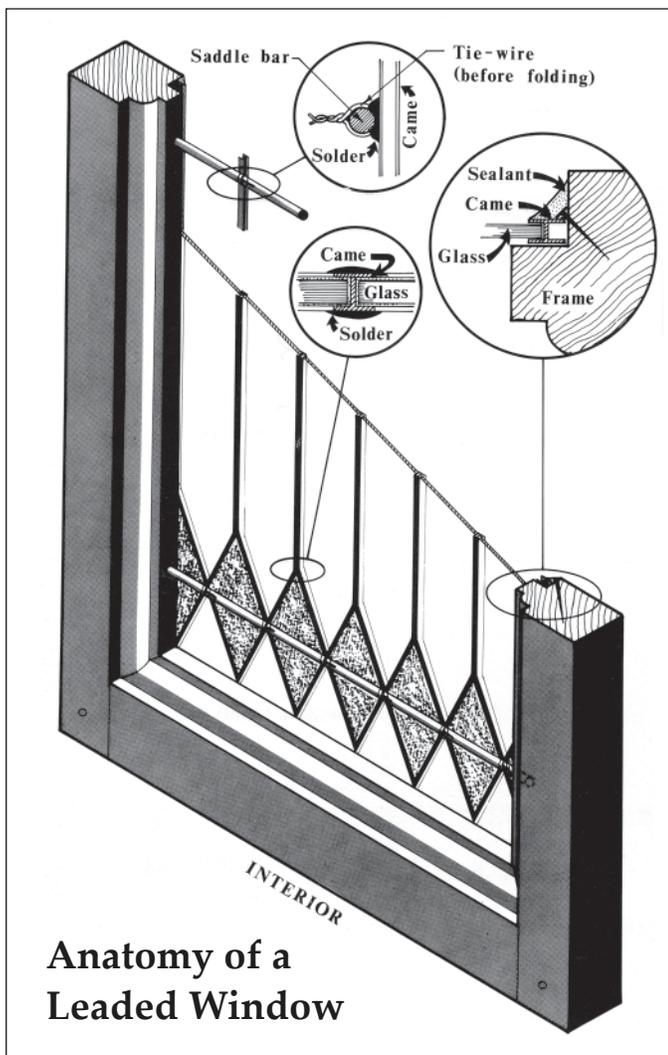
Figure 2. Components of a leaded glass window.

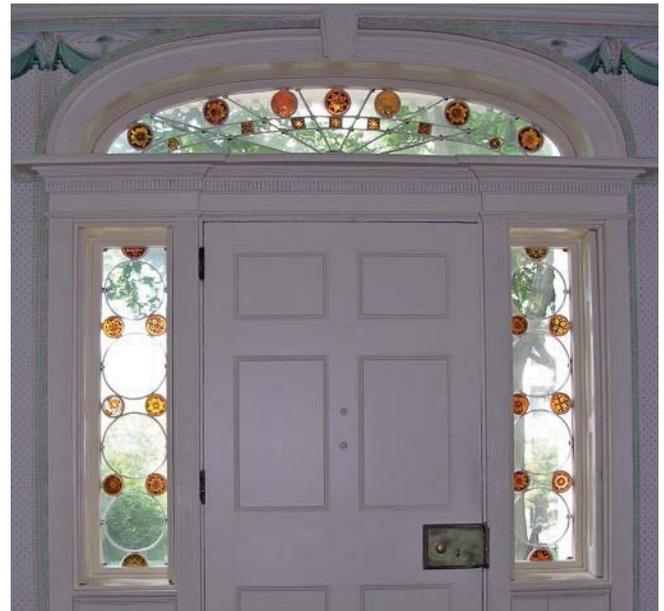
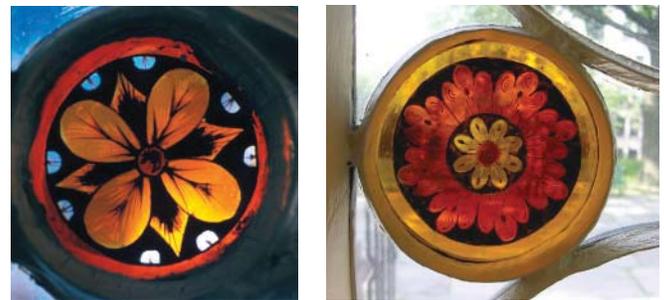
Figure 3. The entrance to the Morris-Jumel Mansion, New York City, is one of the earliest surviving installations of stained glass in the country. It features a fanlight and sidelights of large clear roundels and small bulls-eyes of red and orange glass tinted with silver stains from ca. 1810. Photo: Ken Moss.

from these periods is very significant (Fig. 3). Every effort should be made to document and preserve it.

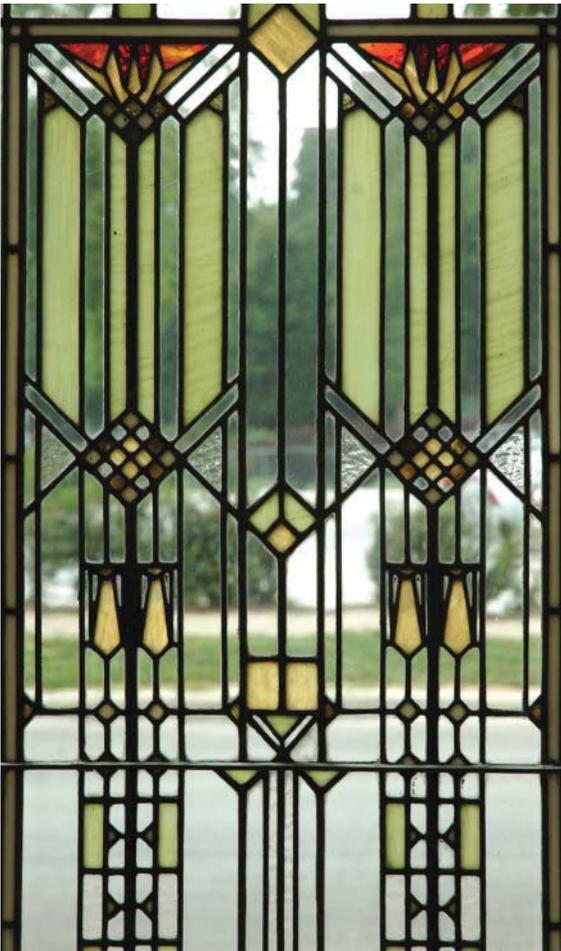
Figure 8. This 1902 window by Henry Webster Tomlinson reflects the Prairie School philosophy of providing ornamentation while retaining a view through the window.

Advocates of the Prairie Style, of whom Frank Lloyd Wright is the best known, rejected Tiffany's naturalistic scenes and Connick's Gothic imitations. (Fig. 8). Wright's rectilinear organic abstractions developed simultaneously with the similar aesthetic of the various European Secessionists. The creation of this style was aided by the development of zinc and copper comes in 1893. These comes—much stiffer than lead—made it possible to carry out the linear designs of Prairie School windows with fewer support bars. At first, these windows had only an elitist following, but they were soon widely accepted and proliferated during the early 20th century.

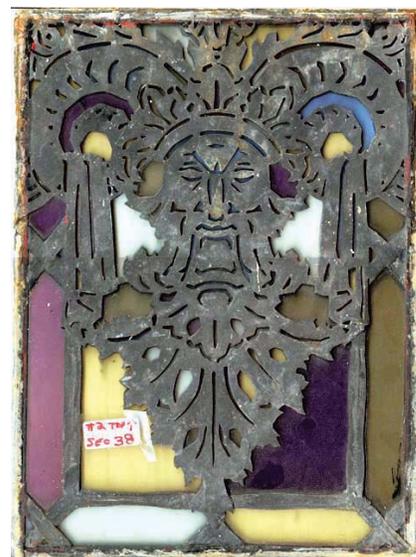
Figure 10. This lead-silhouette stained glass face graces a 1928 coach house in Buffalo, and is attributed to D'Ascenzo Studios of Philadelphia.

Some creative efforts expanded leaded glass media in new directions. Lead-overlay or “silhouette” glass was one novelty that climaxed in the late 1920s and early 1930s. Some designers sandwiched glass between layers of hand-cut sheet lead, while others sandwiched the perforated sheet lead between layers of glass. These windows present a playful reversal from traditional stained glass; in “silhouette” glass the lead metalwork, rather than the glass, becomes the primary art form (Fig. 10). However, such novelties failed to catch on during the Depression. World War II delivered the final blow and ornamental glass is seldom found in residential, commercial, and secular architecture after circa 1940. The great age of American stained glass was over. Fortunately, leaded glass panels survived in uncounted numbers throughout the country, and are now once again appreciated as virtually irreplaceable features of historic buildings.

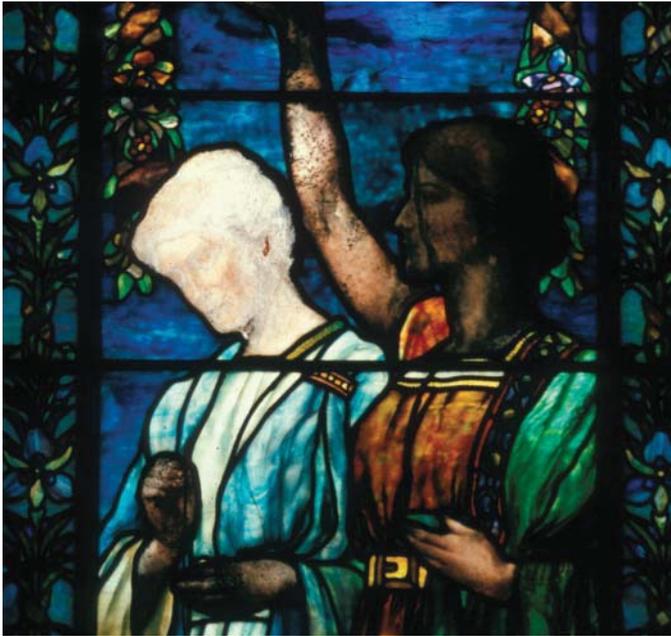
Figure 11. The face paint has failed substantially in the figure at the left. Ghost images of the feature are barely visible. Window (1903) by Edwin P. Sperry, glass by Tiffany Studios; “Old Main,” (1891-1893) Illinois Institute of Technology, Chicago. Photo: Rolf Achilles.

Painted glass, typically associated with pictorial scenes and figures found in church windows, often presents serious preservation challenges. If fired improperly, or if poor quality mixtures were used, painted glass is especially vulnerable to weathering and condensation. Some studios were notorious for poorly fired paints (particularly those working with opalescent glass), while others had outstanding reputations for durable painted glass. Paints can be applied cold on the glass or fused in a kiln. Since they are produced from ground glass, enamels do not “fade,” as often suggested, but rather flake off in particles. Several steps in the painting process can produce fragile paint that is susceptible to flaking. If applied too thick, the paint may not fuse properly to the glass, leaving small bubbles on the surface. This condition, sometimes called “frying,” can also result from poor paint mixtures or retouching. Paint failure is more commonly caused by under firing (i.e., baking the glass either at too low a temperature or for too little time). Unfortunately, in American stained glass, the enamels used to simulate flesh tones were typically generated from several layers that were fired at too low a temperature. This means the most difficult features to replicate—faces, hands and feet—are often the first to flake away (Fig. 11).

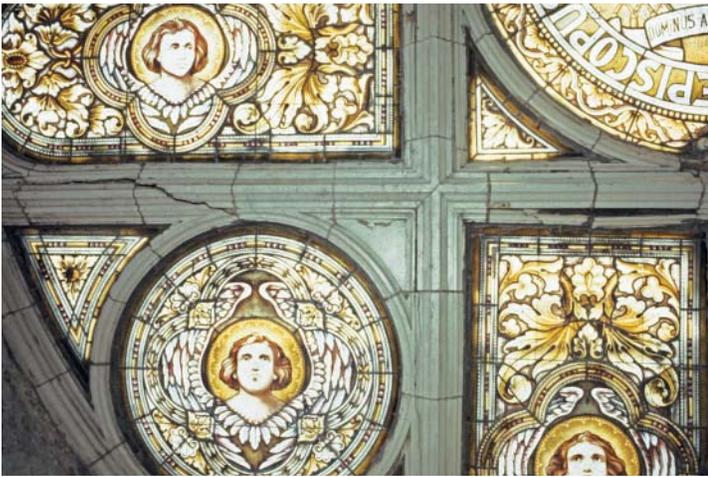
Figure 12. Stained glass frames are typically wood, steel or stone; however, other materials, and their inherent problems, can also be found as seen in this photograph of cracked terra cotta frames from 1926.

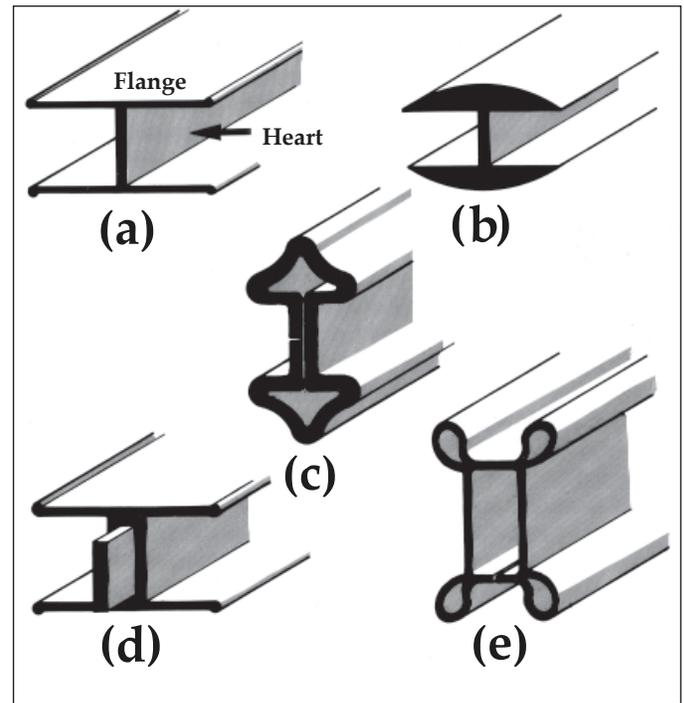
Figure 13. A wide variety of came has been used for ornamental glass in America: (a) flat lead came; (b) round lead came; (c) “Colonial” zinc came; (d) double-heart lead came with a steel core; (e) “Prairie School” zinc came.

Lead and zinc comes are the two most common assembly materials used in stained and other “leaded” glass. The strength and durability of the leaded panel assembly depends upon the type of came, the quality of the craftsmanship, and the glazing concept or design, as well as on the metallic composition of the comes, their cross-section strength, how well they are joined and soldered, and the leading pattern within each panel. Came is prone to natural deterioration from weathering and from thermal expansion and contraction, which causes metal fatigue.

Zinc came is more vulnerable to atmospheric corrosion (particularly from sulfuric acids) than lead, but has proven to be durable in America because it weighs 40% less than lead and its coefficient of expansion is 7% lower. Thus, it is somewhat less susceptible to fatigue from expansion and contraction. Moreover, it is ten times harder than lead, and has three times the tensile strength. Zinc came is strong enough to be self-supporting and requires little bracing to interrupt the window’s design. While zinc came is perfect for the geometric designs of Prairie School windows, it is usually too stiff to employ in curvilinear designs. Zinc can also take several finishes, including a copper or black finish. (As a result, zinc can be mistaken for copper or brass.)

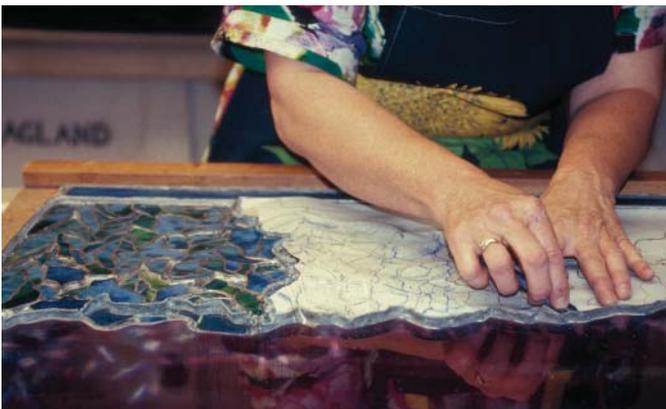
Figure 14. The external glass plate has been removed to clean the interlayer of this plated Tiffany Studios window.

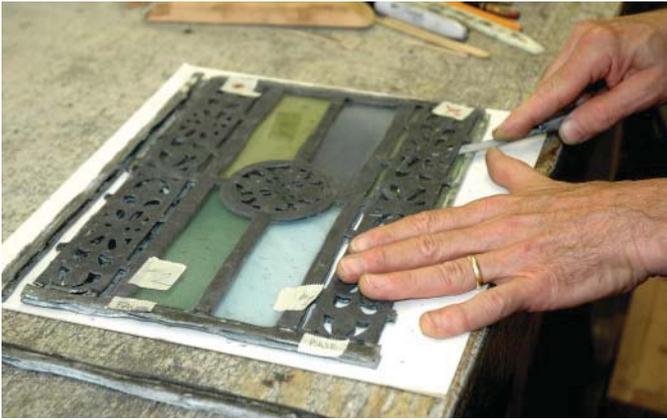
Figure 15. To permit repair of the cracked glass, the original lead overlay is first salvaged from this historic leaded panel of silhouette glass to retain as much of the original work as possible.

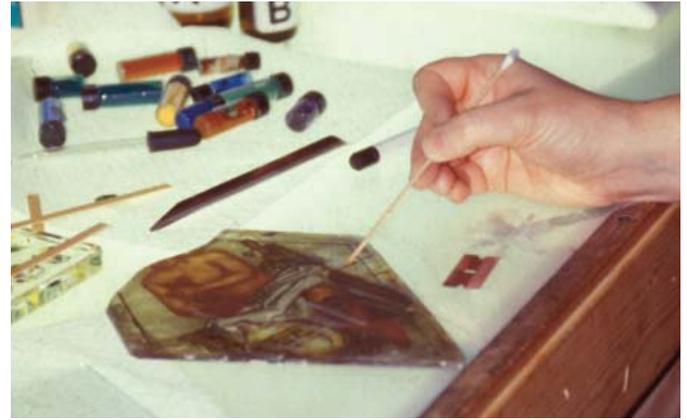
Figure 16. A valuable historic piece of original hand-painted glass is carefully edge-glued with epoxy.

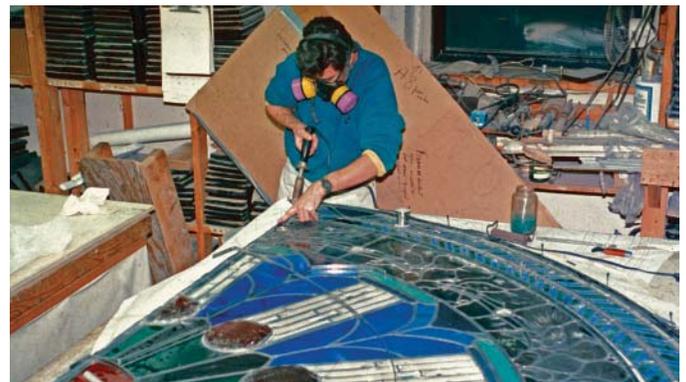
Figure 17. Total releading is very time consuming and costly and should only be undertaken when the original lead is exhausted beyond repair.

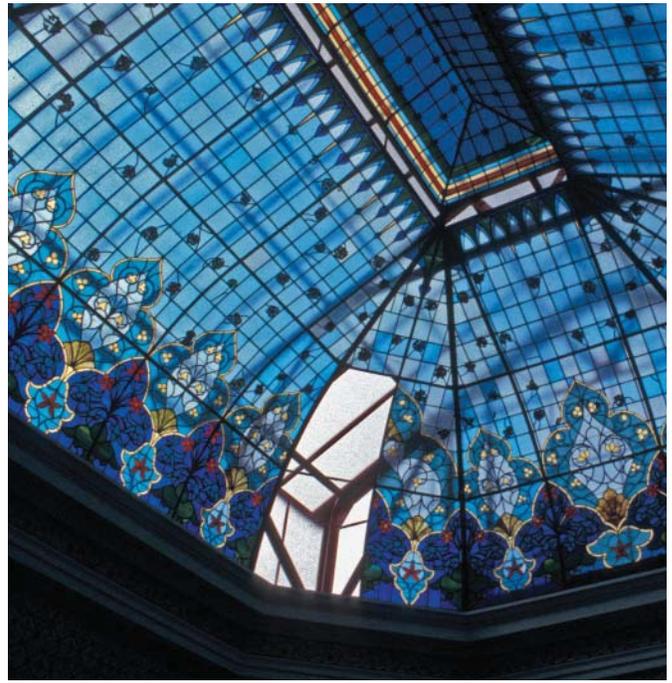
(a) Stained glass ceilings and domes are often principal interior features of churches, hotels, restaurants, railway stations, and civic buildings. This vaulted ceiling illuminates the Cypress Lawn Memorial Gardens mausoleum in Colma, California. The panel removed reveals the diffusing skylight above.

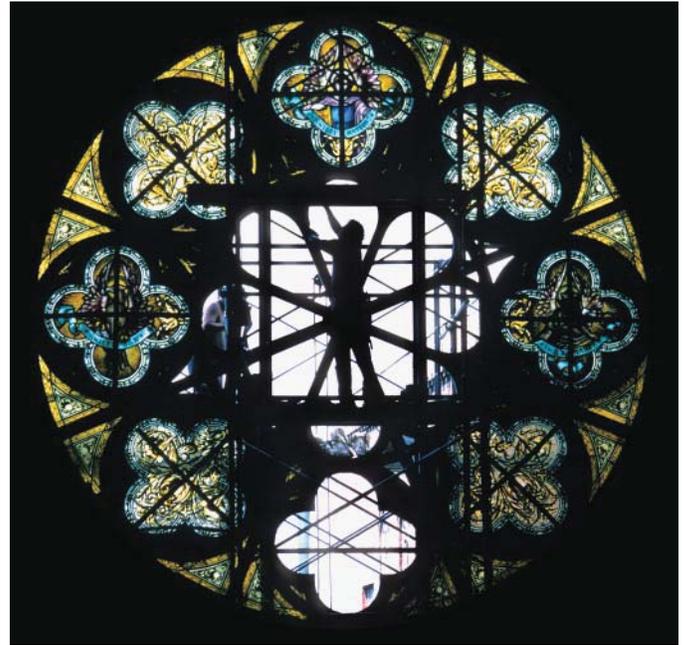
Wooden frame of the rose window undergoing repair (exterior view).
